**Report of the investigation into
the accident resulting in one fatality during the
launching of a Personal Water Craft onboard the motor yacht**

VINYDREA

**in the Bay of St Tropez
on 04 July 2010.**

Casualty 01/2012

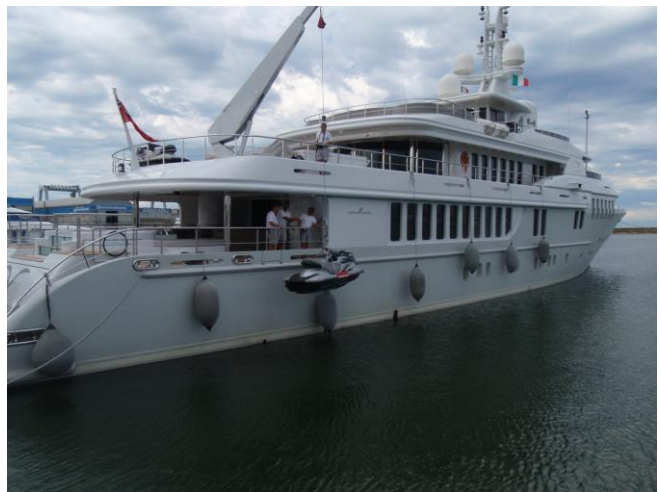
PWC at Main Deck Level where boarded by Deckhand

However, it had become standard practice onboard for someone to ride the first PWC to be launched from main deck level to the sea. When the deckhand boarded the PWC at Main Deck Level, the master was in overall charge of operations and was driving the crane.

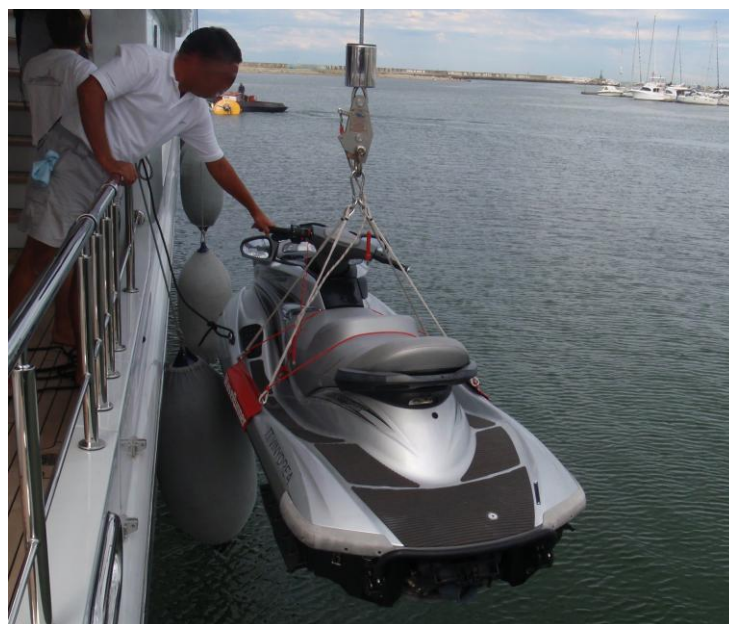
PWC at Main Deck Level where boarded by Deckhand

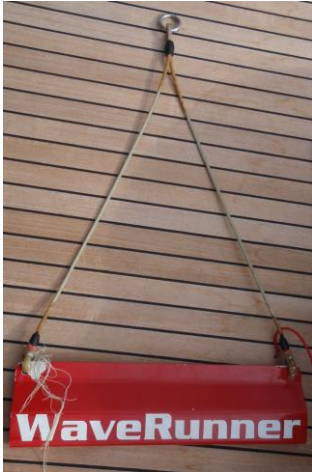
After the accident the failed harness was recovered, although one of the spreaders was lost. The slings attached to the

port spreader indicated failure caused by corrosion of the steel wire rope slings. The slings were attached to the spreaders by swaged wire thimbles. To prevent damage by the metal swage, these had been covered by soft tape⁴. The slings failed in way of the soft tape covering the metal swage on each thimble.

Recovered Harness

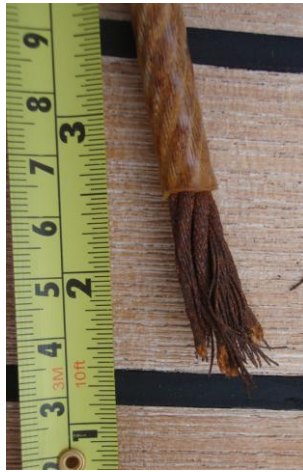
Sling Failure

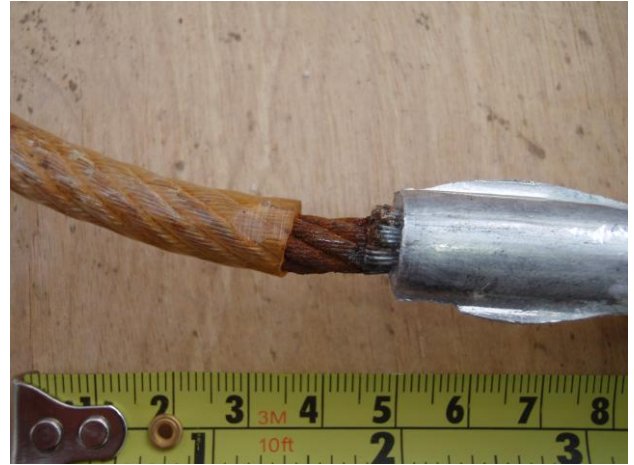
Metal Swage on Sling from Recovered Harness (Soft Tape removed)

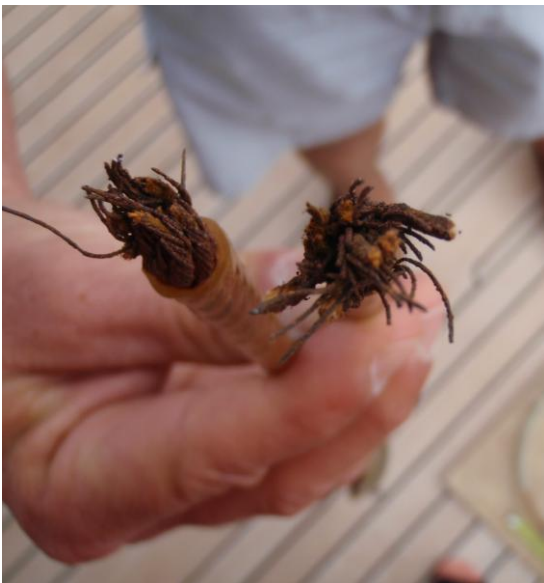
Close up of sling failure

At the point of failure of the cables there was significant corrosion of the steel.

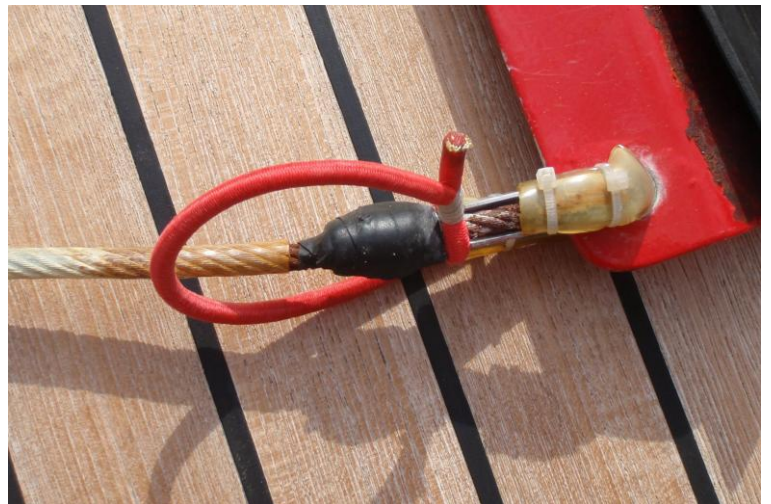
“Soft Tape” used to prevent damage from metal swage with corrosion of wire visible

⁴ Identified as “Self Amalgamating Tape” which is primarily used for producing weather proof seals in electrical applications.

Whereas the “*Testing and certification of loose gear, lifting strops and wires*” does form part of the engineering syllabi for UK yacht specific qualifications¹¹, this topic is introduced at the R.III/2 (Y2)¹² Level. As the “full time” engineer onboard VINYDREA was the holder of a UK R.III/3 (Y4), he cannot be considered as a suitable “competent person” for the examination of such equipment based on this qualification alone. Nevertheless, any person with even limited experience in using lifting slings and the like should have easily been able to recognise the level of corrosion which was clearly apparent at the ends of the steel wire rope slings of the lifting harness. The level of corrosion was apparent despite the application of the protective tape to the swages.

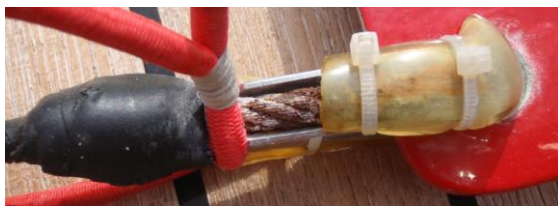
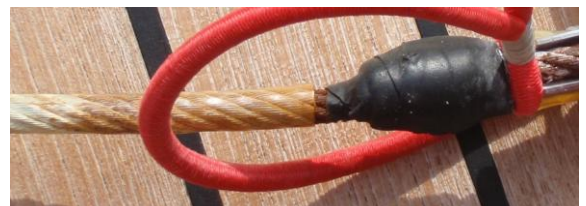
During interviews with crewmembers it was stated that the lifting harnesses for the PWC were “visually inspected before each use” and “rinsed with fresh water after each use”. A visual inspection of the recovered harness showed strong evidence of corrosion of the steel wires under the clear plastic coating and in way of the thimble attachments to the spreaders, as shown below.

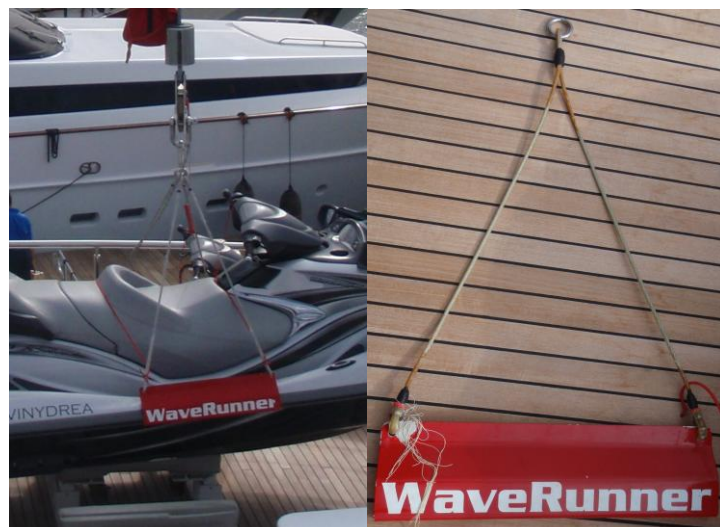
The lifting harness in use was supplied in June 2008 to the yacht during construction by a yacht chandler in Istanbul. As the harness was not accompanied by any manufacturer’s paper work and bore no markings as to either manufacturer or test, it is reasonable to conclude that the harness was neither manufactured nor approved for use by the Yamaha Motor Company. Yamaha manufactured lifting harnesses are made from webbing and vinyl coated fabricated brackets and have only a passing resemblance to the lifting harness in use onboard.

Lifting Harness in use
