**Report of the investigation into
the accident resulting in one fatality during the
launching of a Personal Water Craft onboard the motor yacht**

VINYDREA

**in the Bay of St Tropez
on 04 July 2010.**

Casualty 01/2012

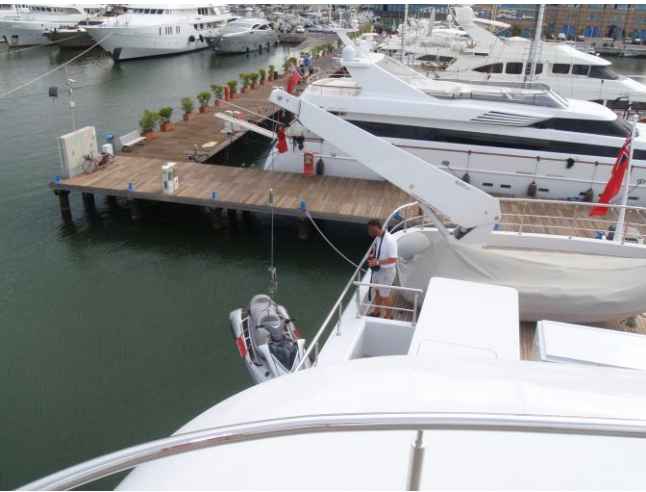
The deckhand was standing on the PWC and steadying himself by holding onto the crane fall above the hook. When lowering recommenced two of the lifting slings used to transport the PWC failed. The port aft sling was the first to fail closely followed by the port forward sling. This caused the PWC to fall to the water, landing on its side and righting itself. Without the support of the PWC, the deckhand was unable to prevent also falling to the sea. The falling deckhand hit the PWC in the water. He landed on the PWC face down with his chest striking the seat of the now free floating PWC. The deckhand entered the water and then regained the surface. The deckhand was conscious and talking but in obvious pain.

Lowering PWC to Main Deck Level

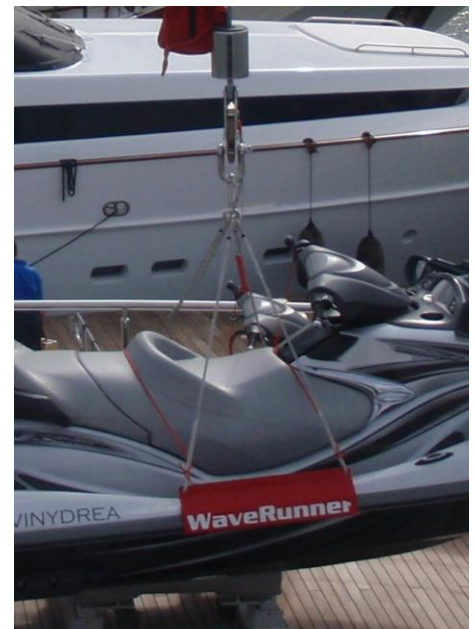
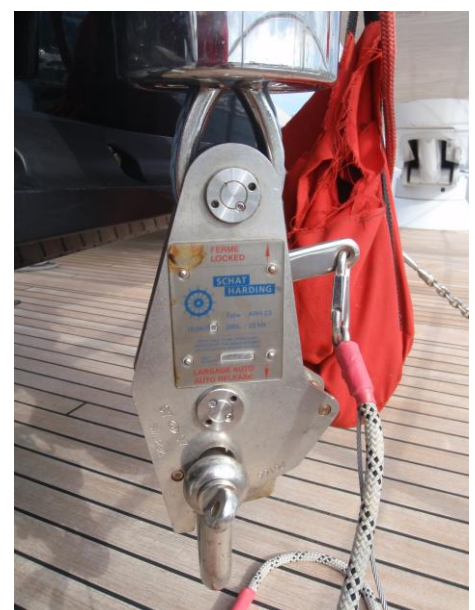
After the accident the failed harness was recovered, although one of the spreaders was lost. The slings attached to the

port spreader indicated failure caused by corrosion of the steel wire rope slings. The slings were attached to the spreaders by swaged wire thimbles. To prevent damage by the metal swage, these had been covered by soft tape⁴. The slings failed in way of the soft tape covering the metal swage on each thimble.

Sling Failure

Close up of sling failure

“Soft Tape” used to prevent damage from metal swage with corrosion of wire visible

During interviews with crewmembers it was stated that the lifting harnesses for the PWC were “visually inspected before each use” and “rinsed with fresh water after each use”. A visual inspection of the recovered harness showed strong evidence of corrosion of the steel wires under the clear plastic coating and in way of the thimble attachments to the spreaders, as shown below.

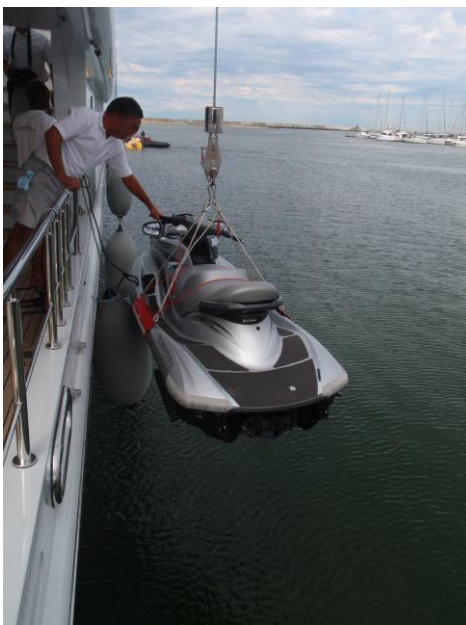
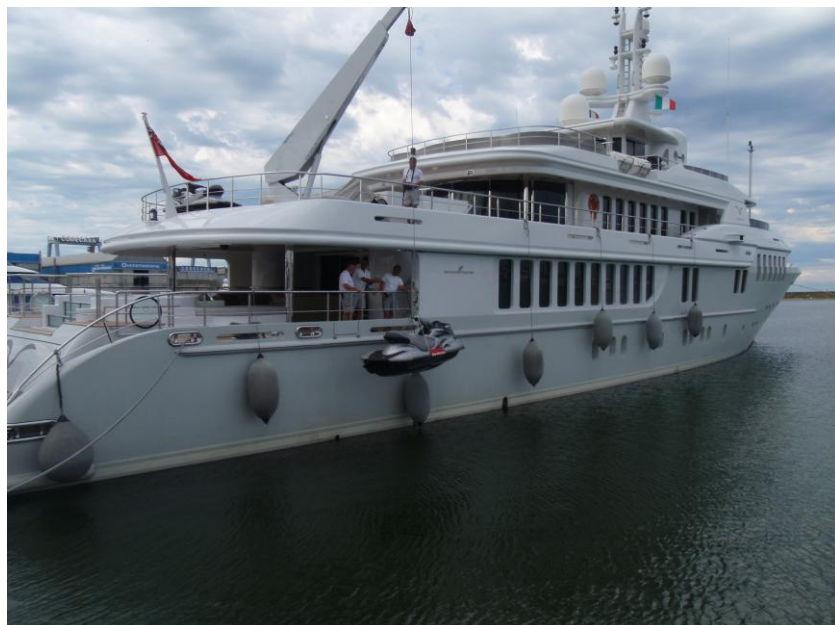
Normal Boarding Position of PWC

However, it had become standard practice onboard for someone to ride the first PWC to be launched from main deck level to the sea. When the deckhand boarded the PWC at Main Deck Level, the master was in overall charge of operations and was driving the crane.

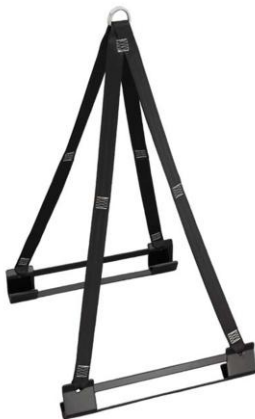
Lifting Harness from Yamaha

The lifting harness in use was supplied in June 2008 to the yacht during construction by a yacht chandler in Istanbul. As the harness was not accompanied by any manufacturer’s paper work and bore no markings as to either manufacturer or test, it is reasonable to conclude that the harness was neither manufactured nor approved for use by the Yamaha Motor Company. Yamaha manufactured lifting harnesses are made from webbing and vinyl coated fabricated brackets and have only a passing resemblance to the lifting harness in use onboard.
